# Manhole Inspection Summary

Manhole # S33SS\_026MH

Insp Date: **4/17/07 1:58 PM**

**Location** Address: **2644 MACE ST**

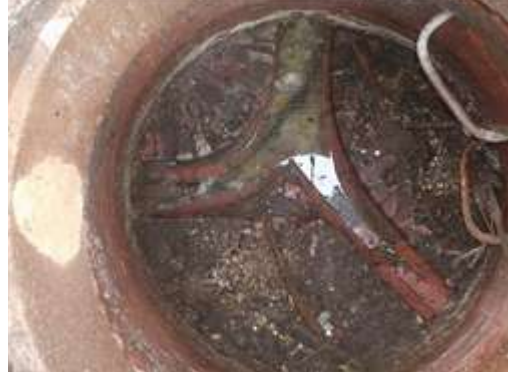
Top View

Corroded steps. Evidence of surcharge - Bench debris. Channel debris.

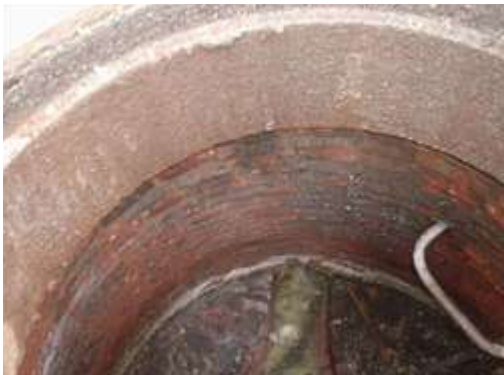
Defect

Frame leaks. Adjustment deterioration and infiltration. Corbel and Barrel infiltration - other side.

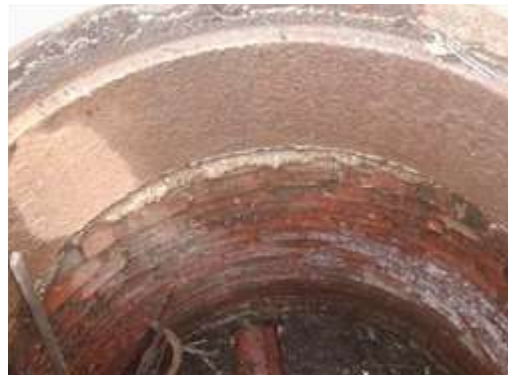
Defect

Frame leaks. Adjustment deterioration and infiltration. Corbel and Barrel infiltration.

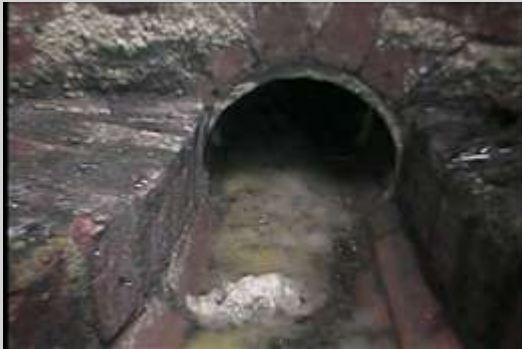
### 8 in. Circular Gravity Sewer Pipe Out @ 12 O'Clock

Deposits: ☐ None ☒ **Mud** ☐ Sludge ☒ **Debris** ☒ **Grease**

Silt Depth: **0.5** (in.) Deposits Extent: **Light**

Infiltration: **Evidence** Pipe Seal Cond: **Unknown**

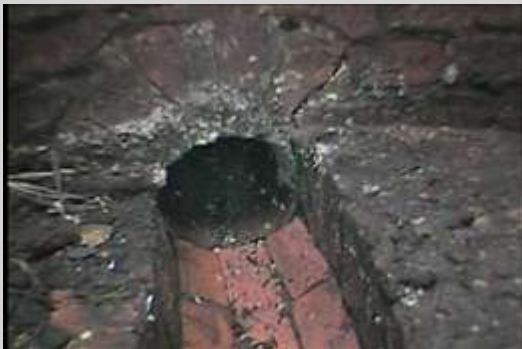
### 6 in. Circular Gravity Sewer Pipe In @ 4 O'Clock

Barrel deterioration and infiltration. Channel deterioration.

Deposits: ☐ None ☒ **Mud** ☐ Sludge ☒ **Debris** ☐ Grease

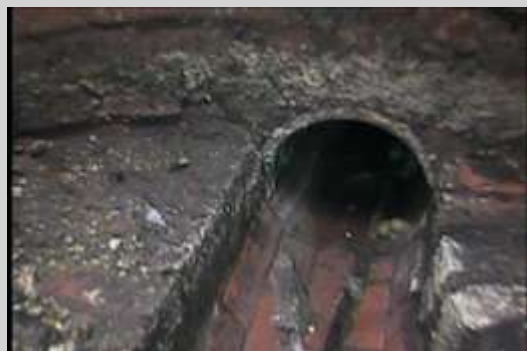
Pipe In @ 9 O'Clock

Deposits: ☐ None ☐ Mud ☐ Sludge ☒ **Debris** ☐ Grease
